HISTORIC PRESERVATION CERTIFICATION
APPLICATION—PART 1

1. Name of property: 1722 West Lexington Street
Address of property: 1722 West Lexington Street
City Baltimore County _____ State Maryland Zip Code 21223
Name of historic district in which property is located: Franklin Square Historic District

CONTINUATION SHEET FOR:
1722 West Lexington St., Baltimore, Md. 21223
Franklin Square Historic District
HISTORIC PRESERVATION CERTIFICATION APPLICATION-PART 1

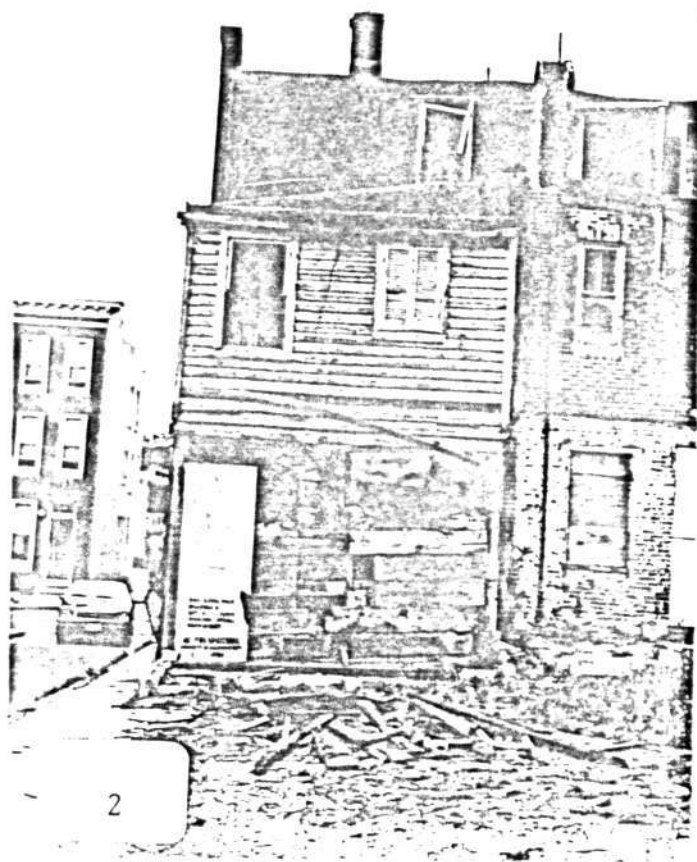
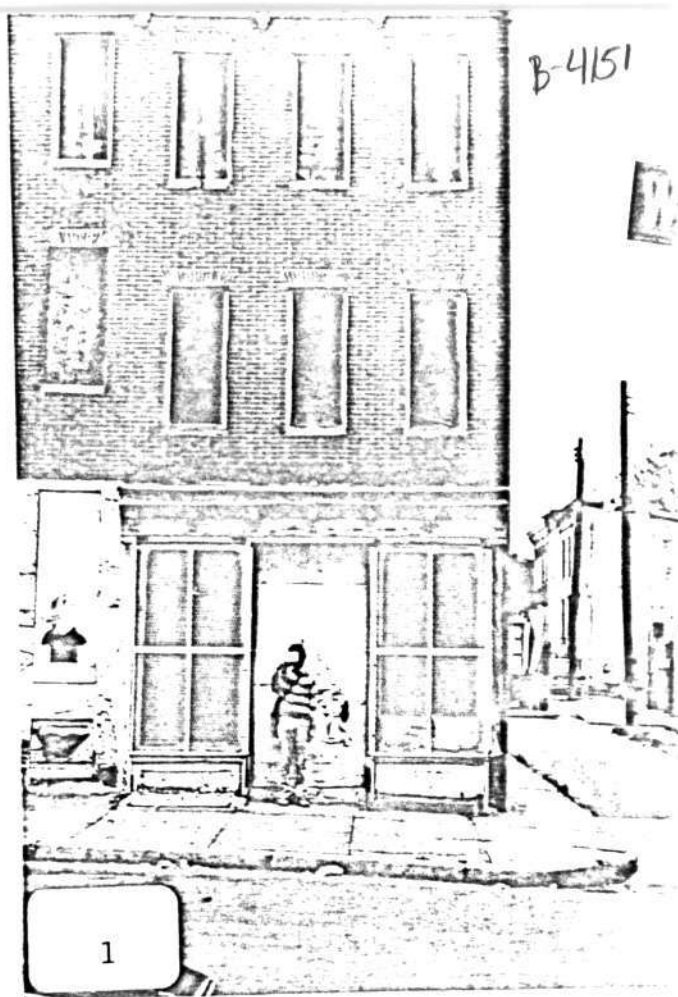
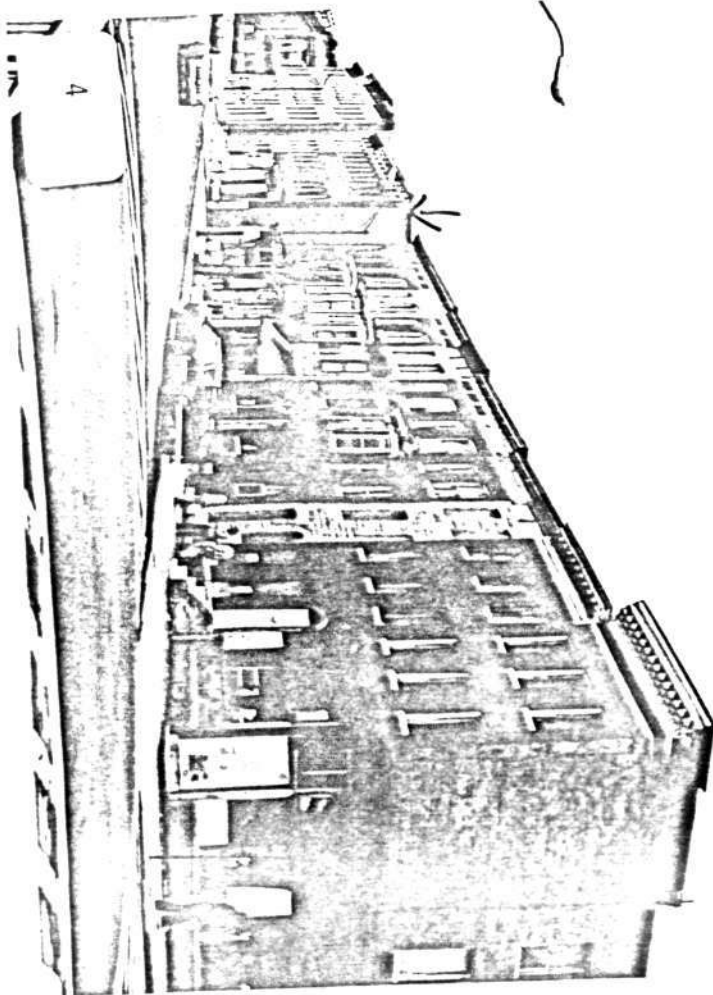
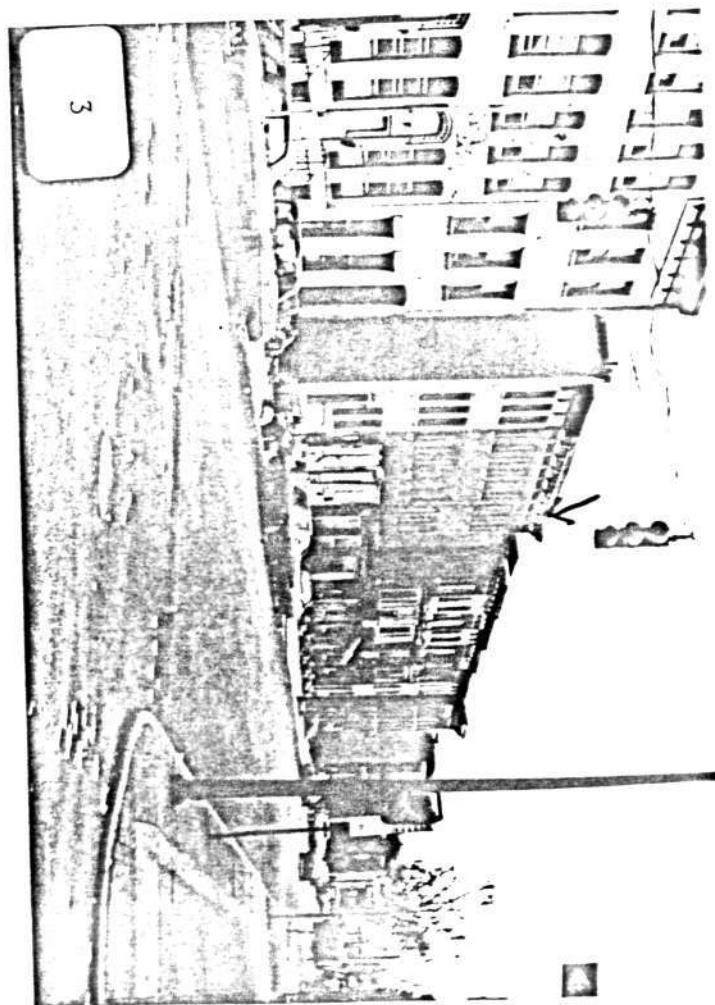
See photographs 1, 2, 3, and 4.

2. across the storefront windows. There has been water and termite damage to the rear interior floors, walls and ceilings, however, the front of the house has fairly good floors, and some trim and moldings remain. Two fireplaces are in the house, the first floor fireplace is torn down but the second floor fireplace has the original marble mantel. Some of the paneling and shelving remain in the storefront area front. The pipes in the house are all exposed. The banister and railings remain fairly intact and in good shape with the exception of a few missing ballisters.

3. Although there has been extensive termite and water damage to the rear portion of the house, the floors, trim, casings and moldings remain in fairly good shape in the front. The storefront room has been vandalized but some of the original shelving remains. The banisters and railing on the stairway is in good shape except for a few missing ballisters. The first floor rear fireplace has no mantle but an exceptional inlaid marble mantle still adorns the second floor fireplace. Further, jack arches highlight the second and third floor windows in the front.
